Limited Visual Dam Safety Inspection Summary Report

MA-141

Wailuku Project District Retention Basin

Limited Visual Dam Safety Inspection Conducted on: 03 April 2006

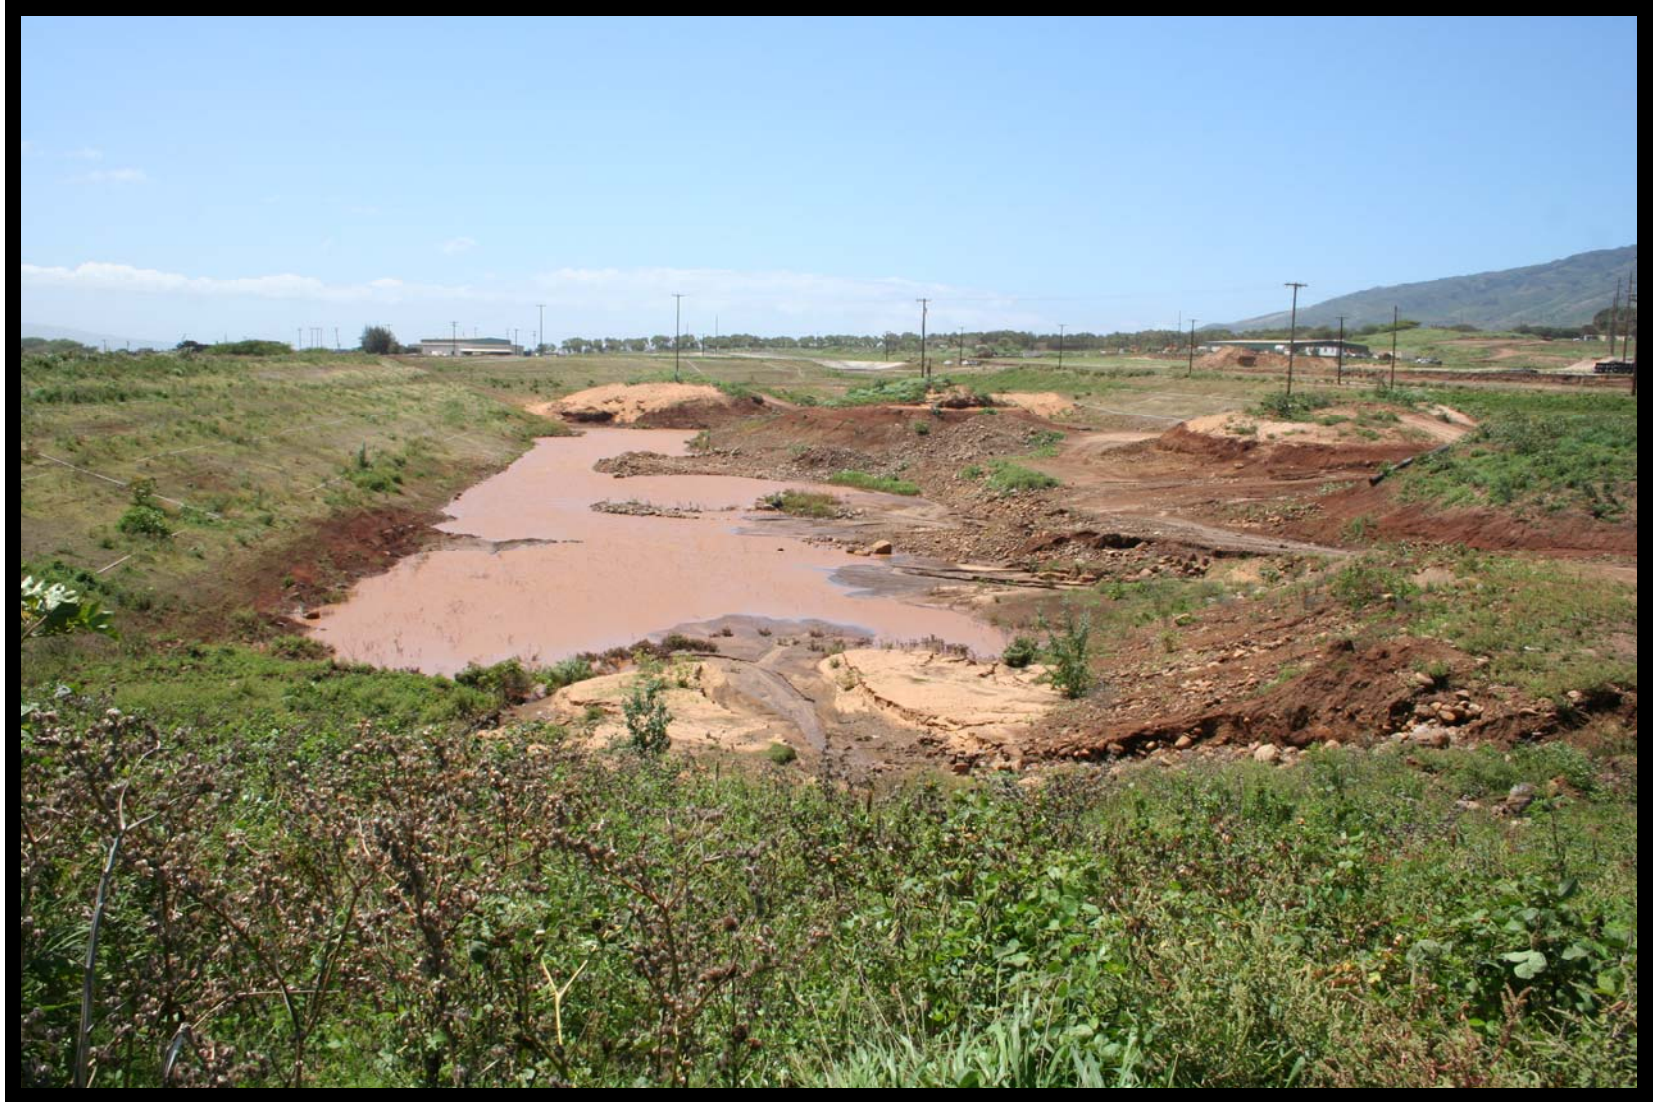
141 unfinished reservoir looking from the north.

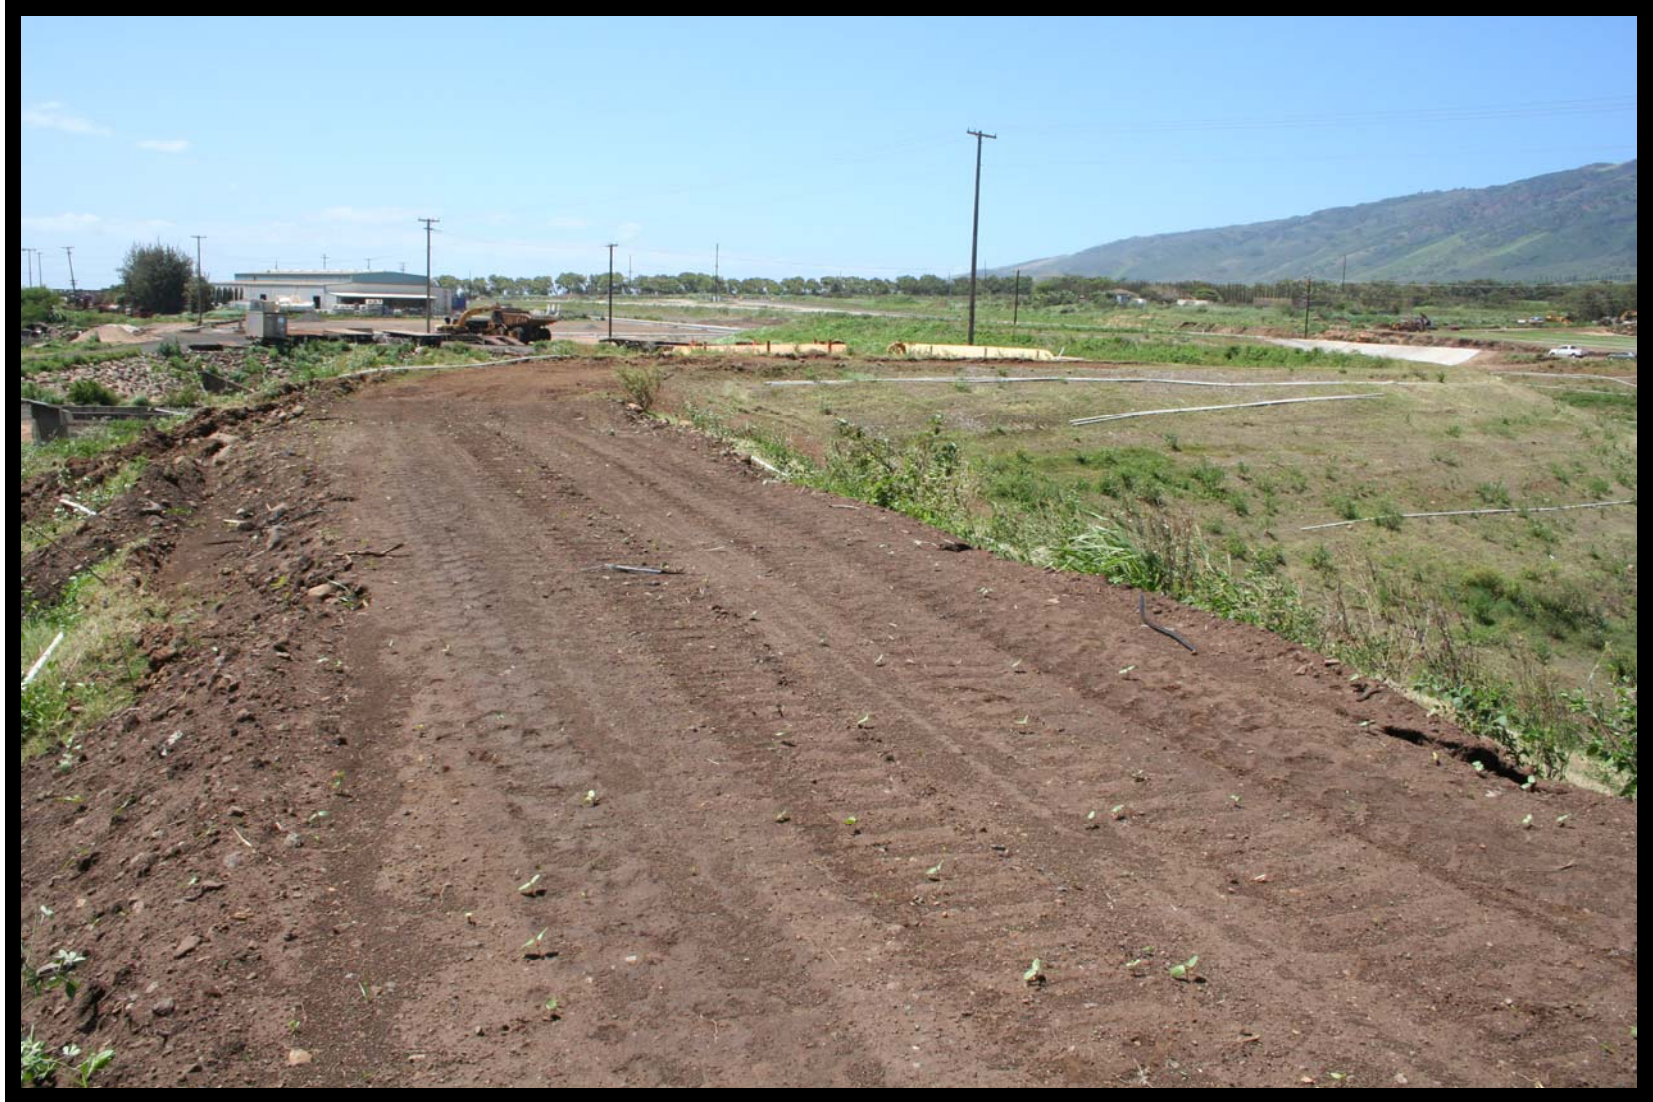
141 uneven crest to south - Crest area that is about 1' lower than other areas looking south

- The dam crest appeared to be in fair condition and requires corrective action.
- Access along the crest was satisfactory.
- Repair surface erosion and monitor crest for any developing cracks.
- The crest is not level due to ongoing construction. The crest must be made level.

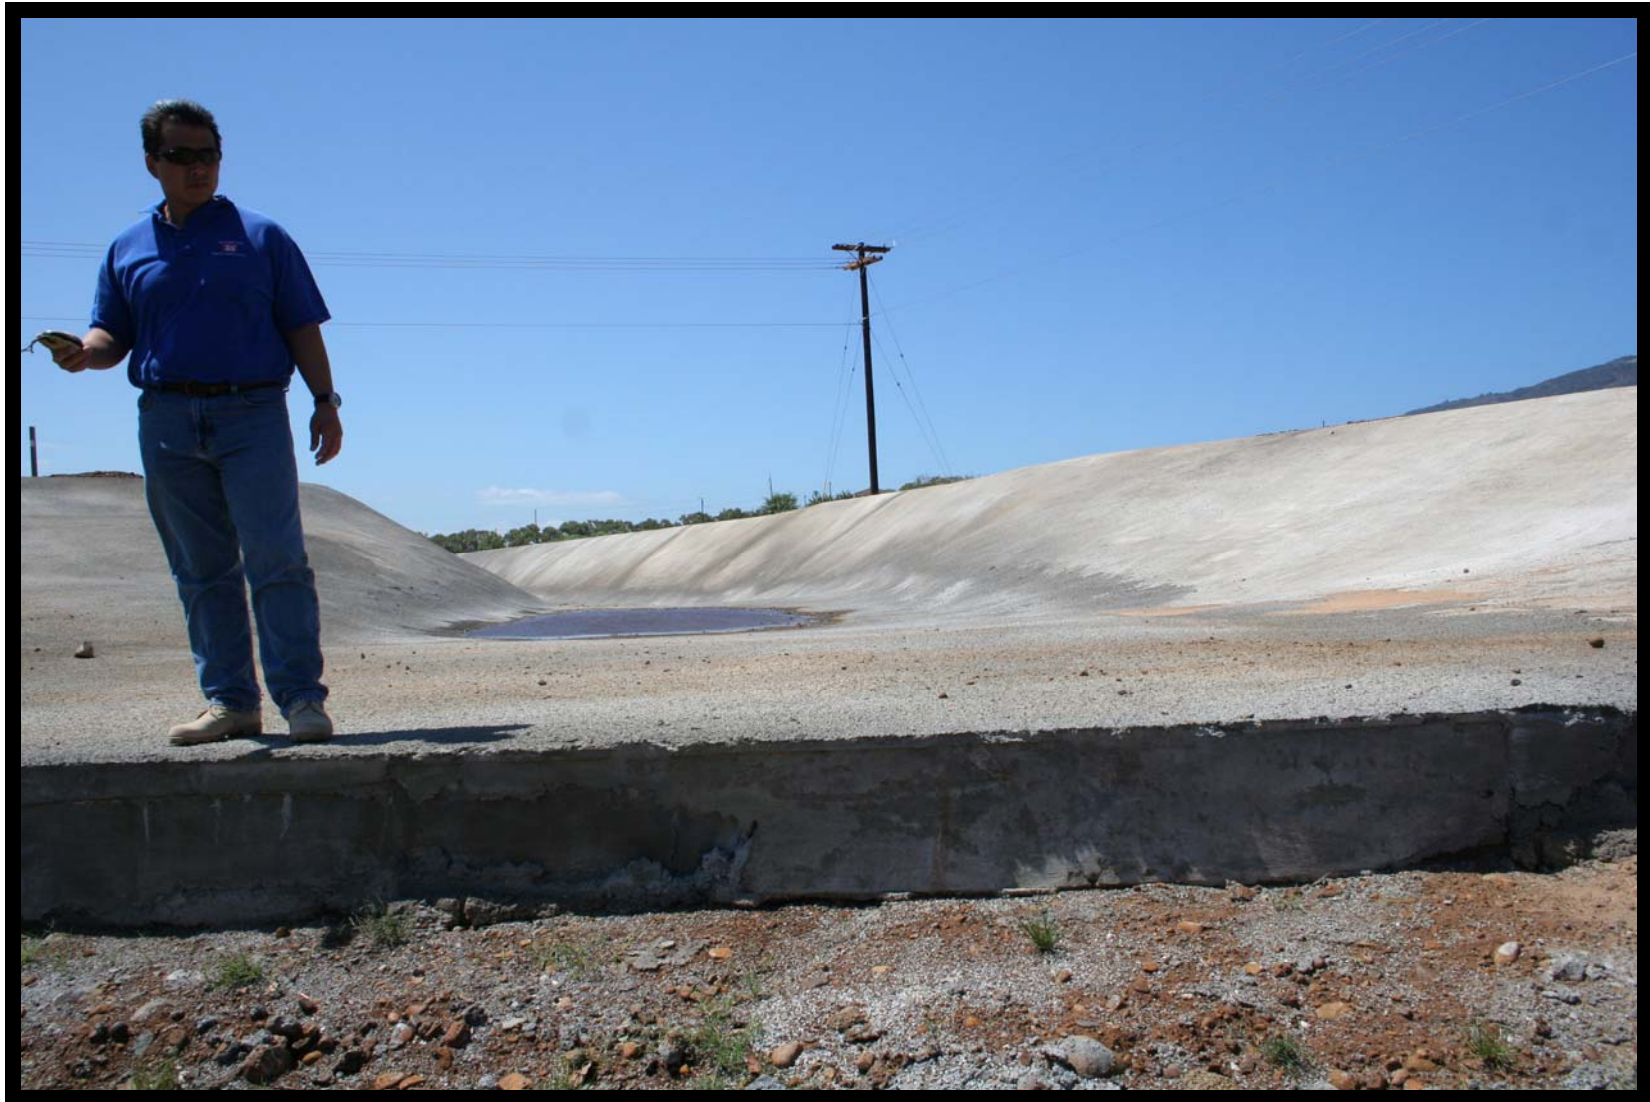
141 spillway shotcrete - Upstream edge of shotcrete spillway lining showing absence of toe wall under shotcrete

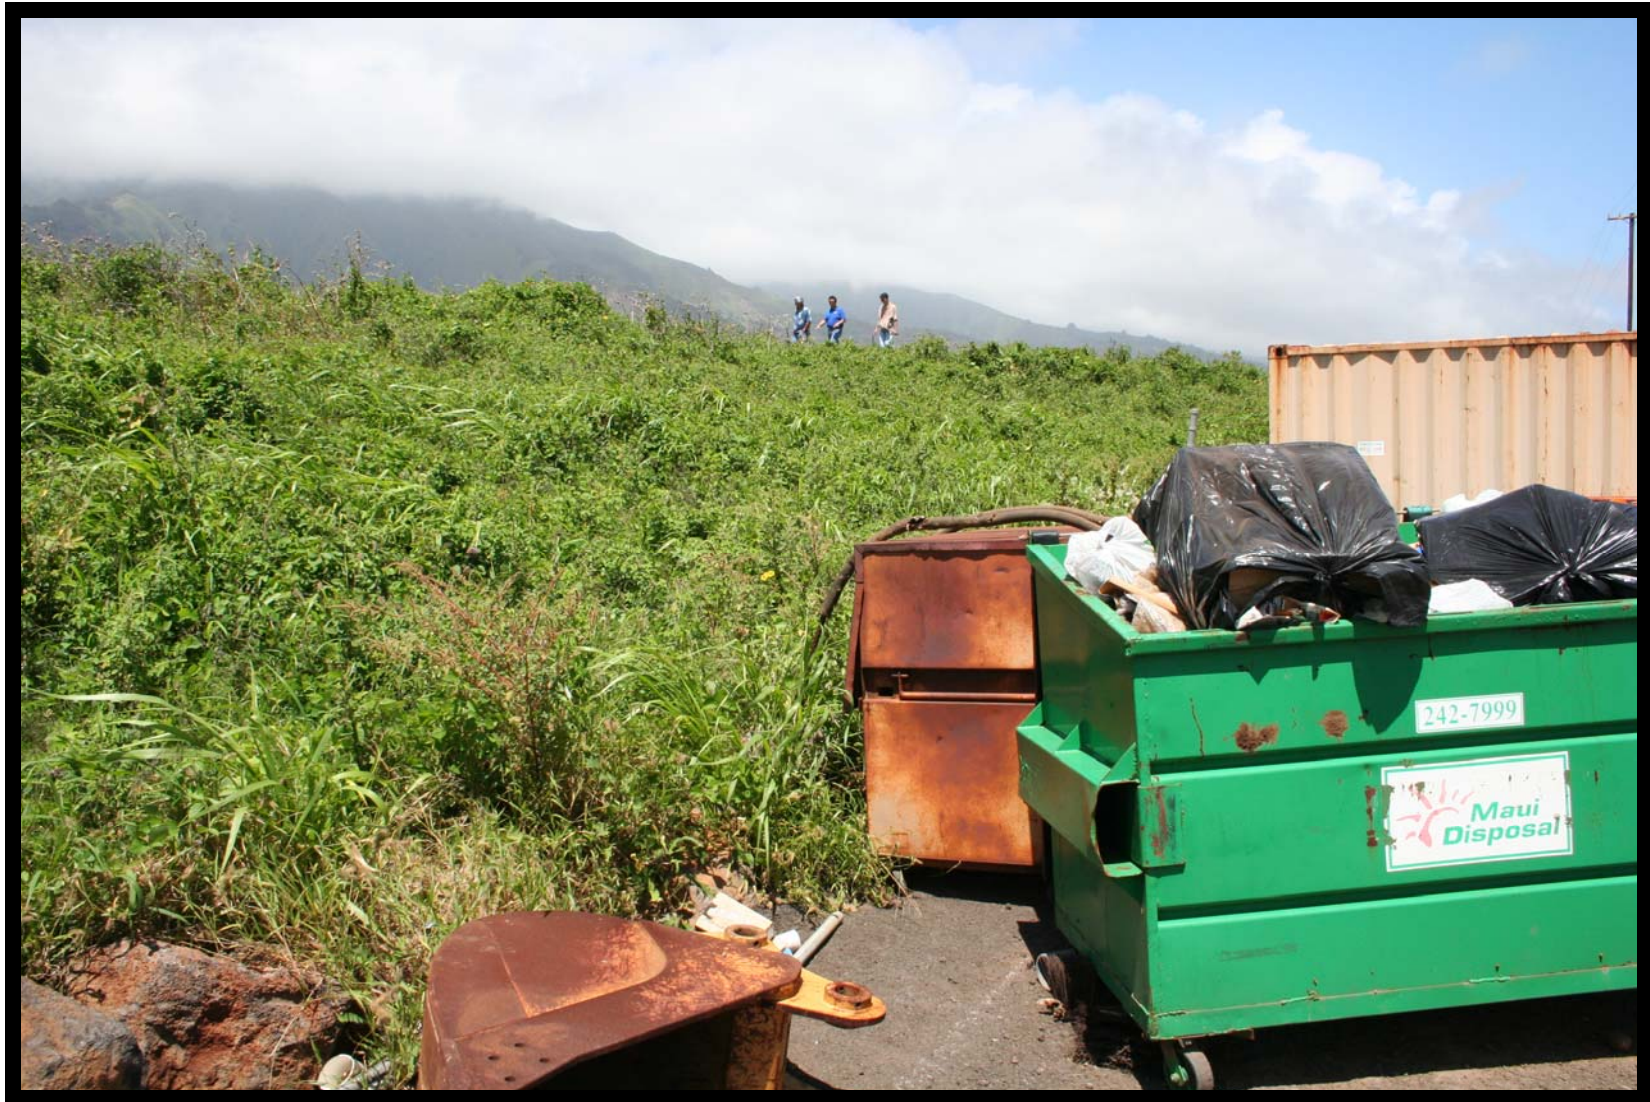
141 south heavy vegetation 1 - Back slope of south embankment showing heavy vegetation

- The downstream slope appeared to be in fair to poor condition and requires corrective action.
- Rut and/or Gully erosion was observed on the slope, which requires maintenance and/or repair. Description: Improve grass cover and grade minor erosion.
- The down stream slope was not visible due to high grass on the south side. Clear high vegetation and maintain low to enable easy visual inspection.

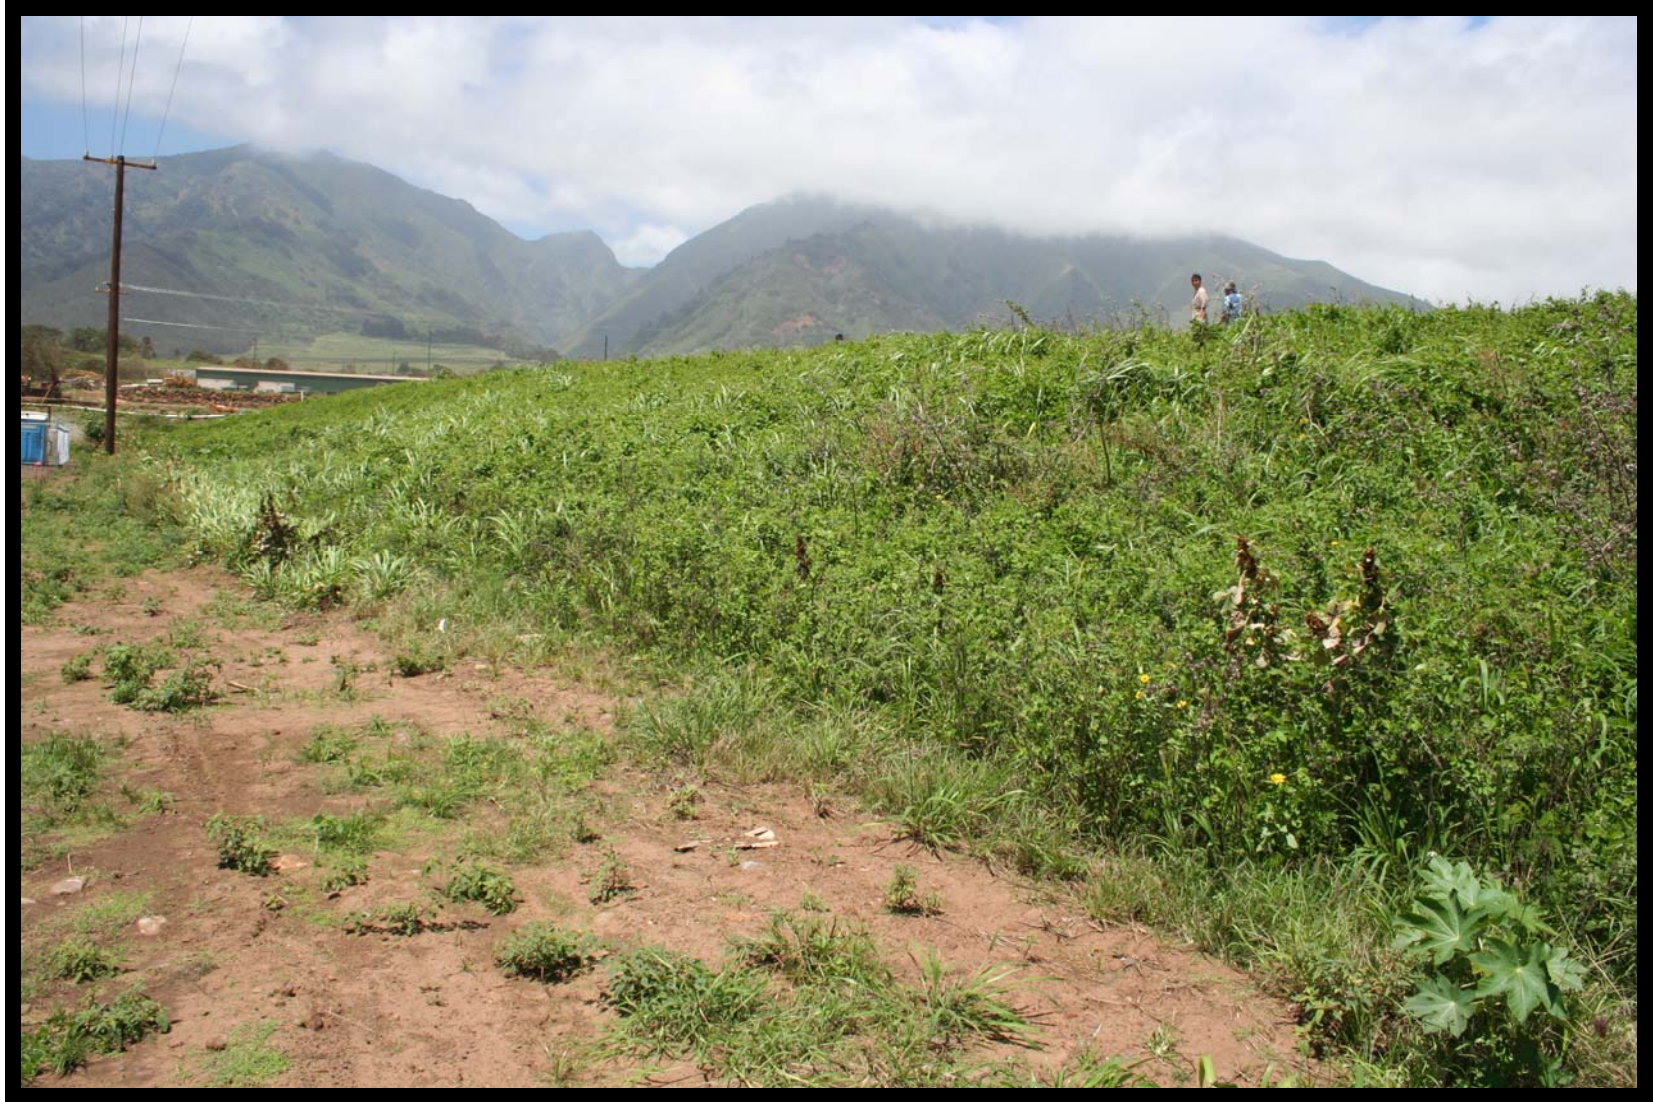
141 south heavy vegetation 2 - Back slope of south embankment showing heavy vegetation

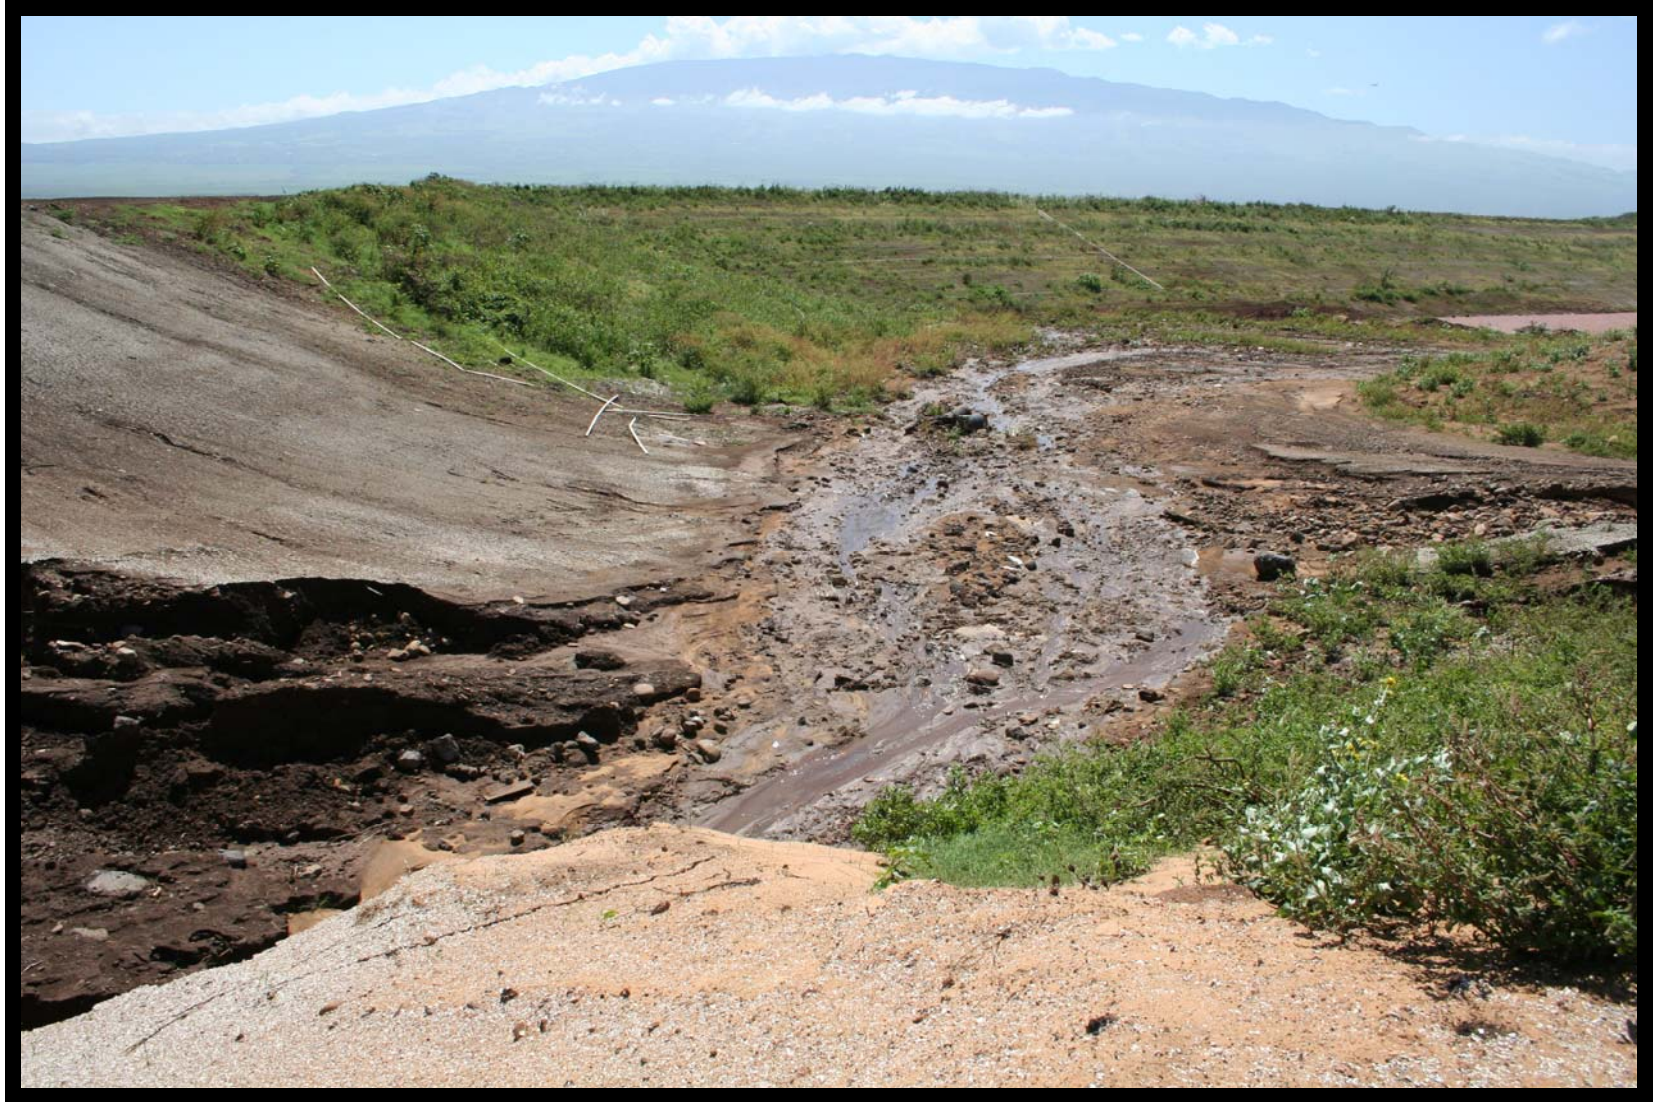
The inflow ditch and pipes are in fair condition. Headcutting is occurring where the ditch enters the basin. Owner intends to armor during construction. Inflows are not divertable and are driven by drainage area.

141 inlet head cutting - Looking from inlet channel to basin

- a. The intake works appeared to be in fair to poor condition and requires corrective action.
- b. The intake works needs maintenance and/or repair. Description: Repair head cutting and armor area where ditch enters basin.

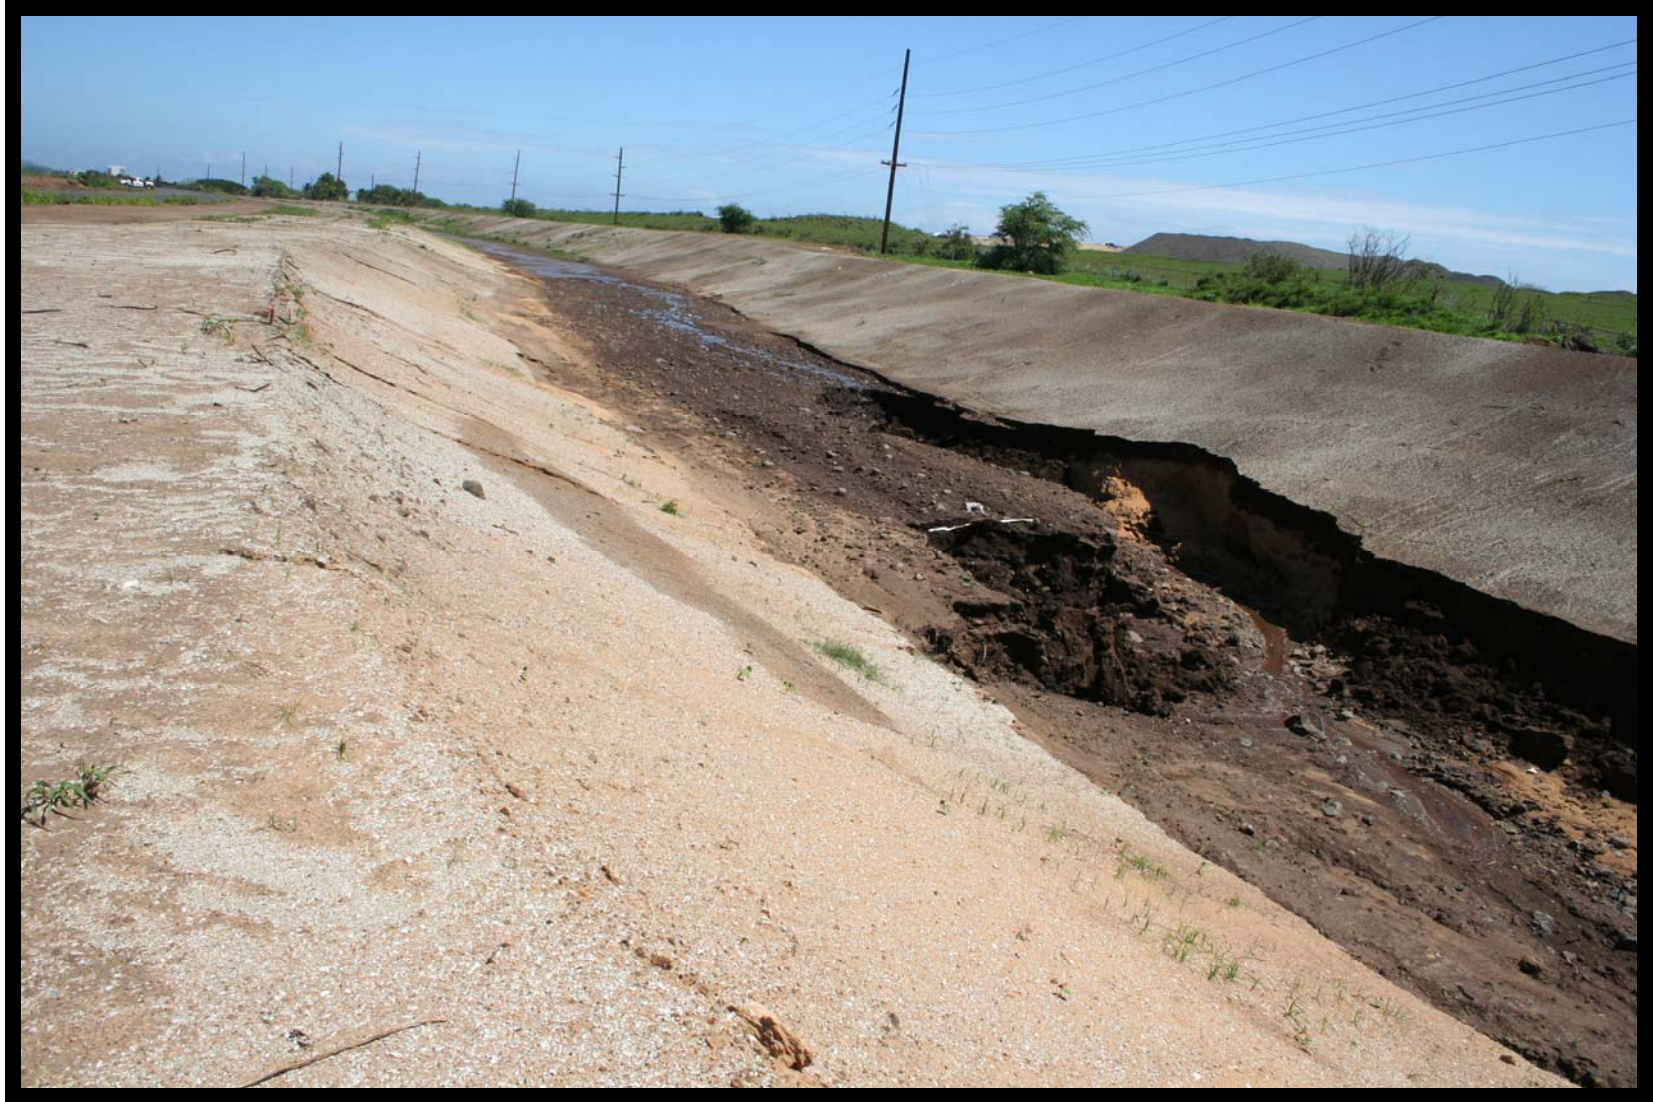
141 inlet head cut - Inlet channel and head cutting where channel meets the basin

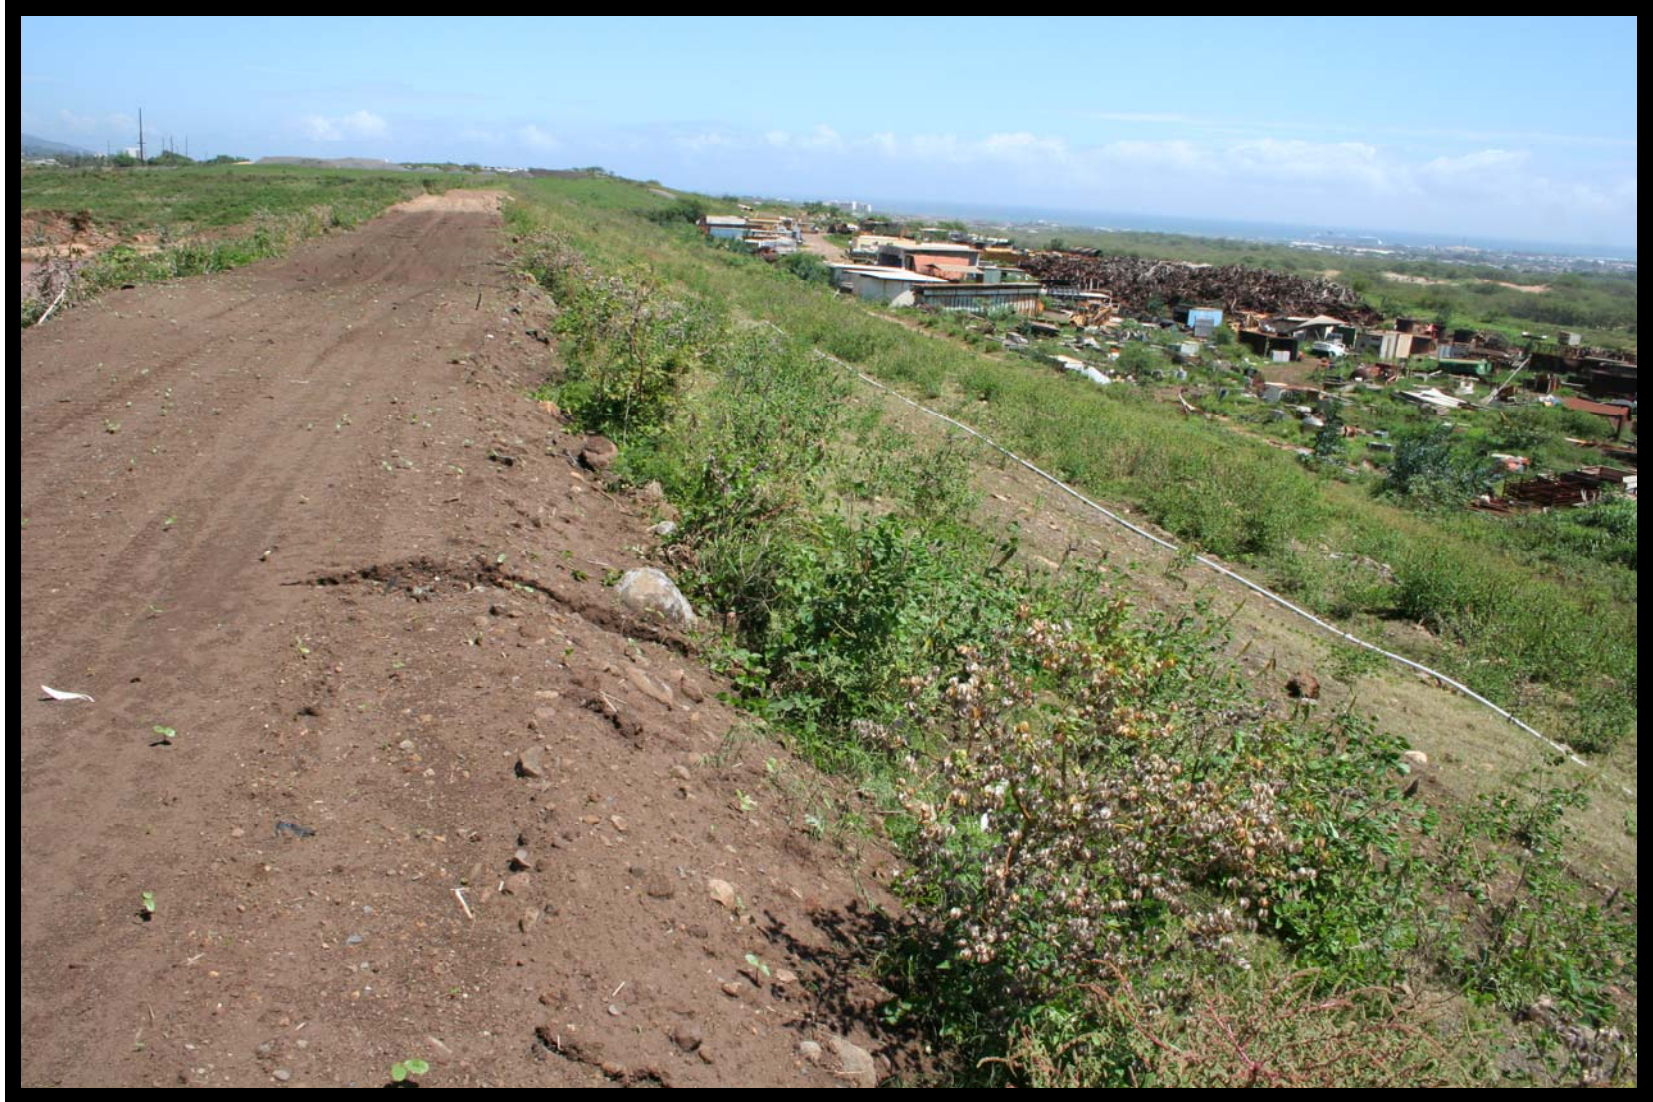
141 east uneven crest - Crest area that is about 1' lower than other areas

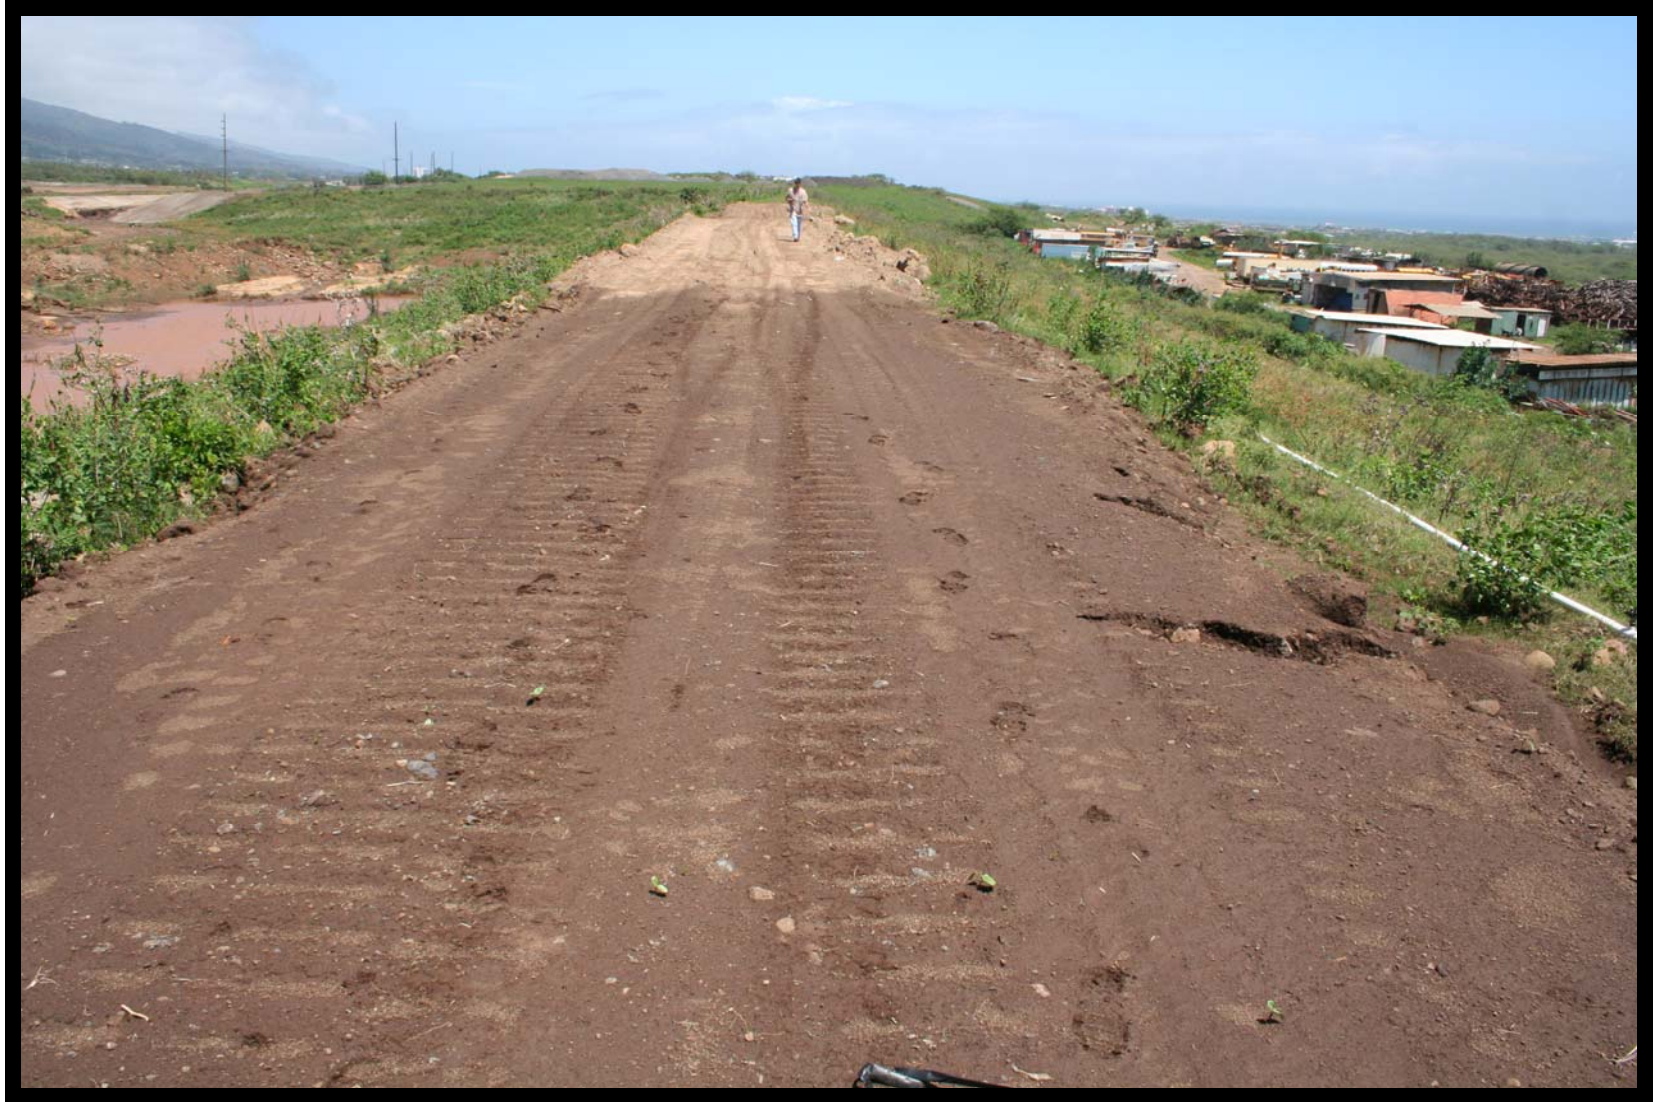
141 east uneven crest 1 - Crest area that is about 1' lower than other areas

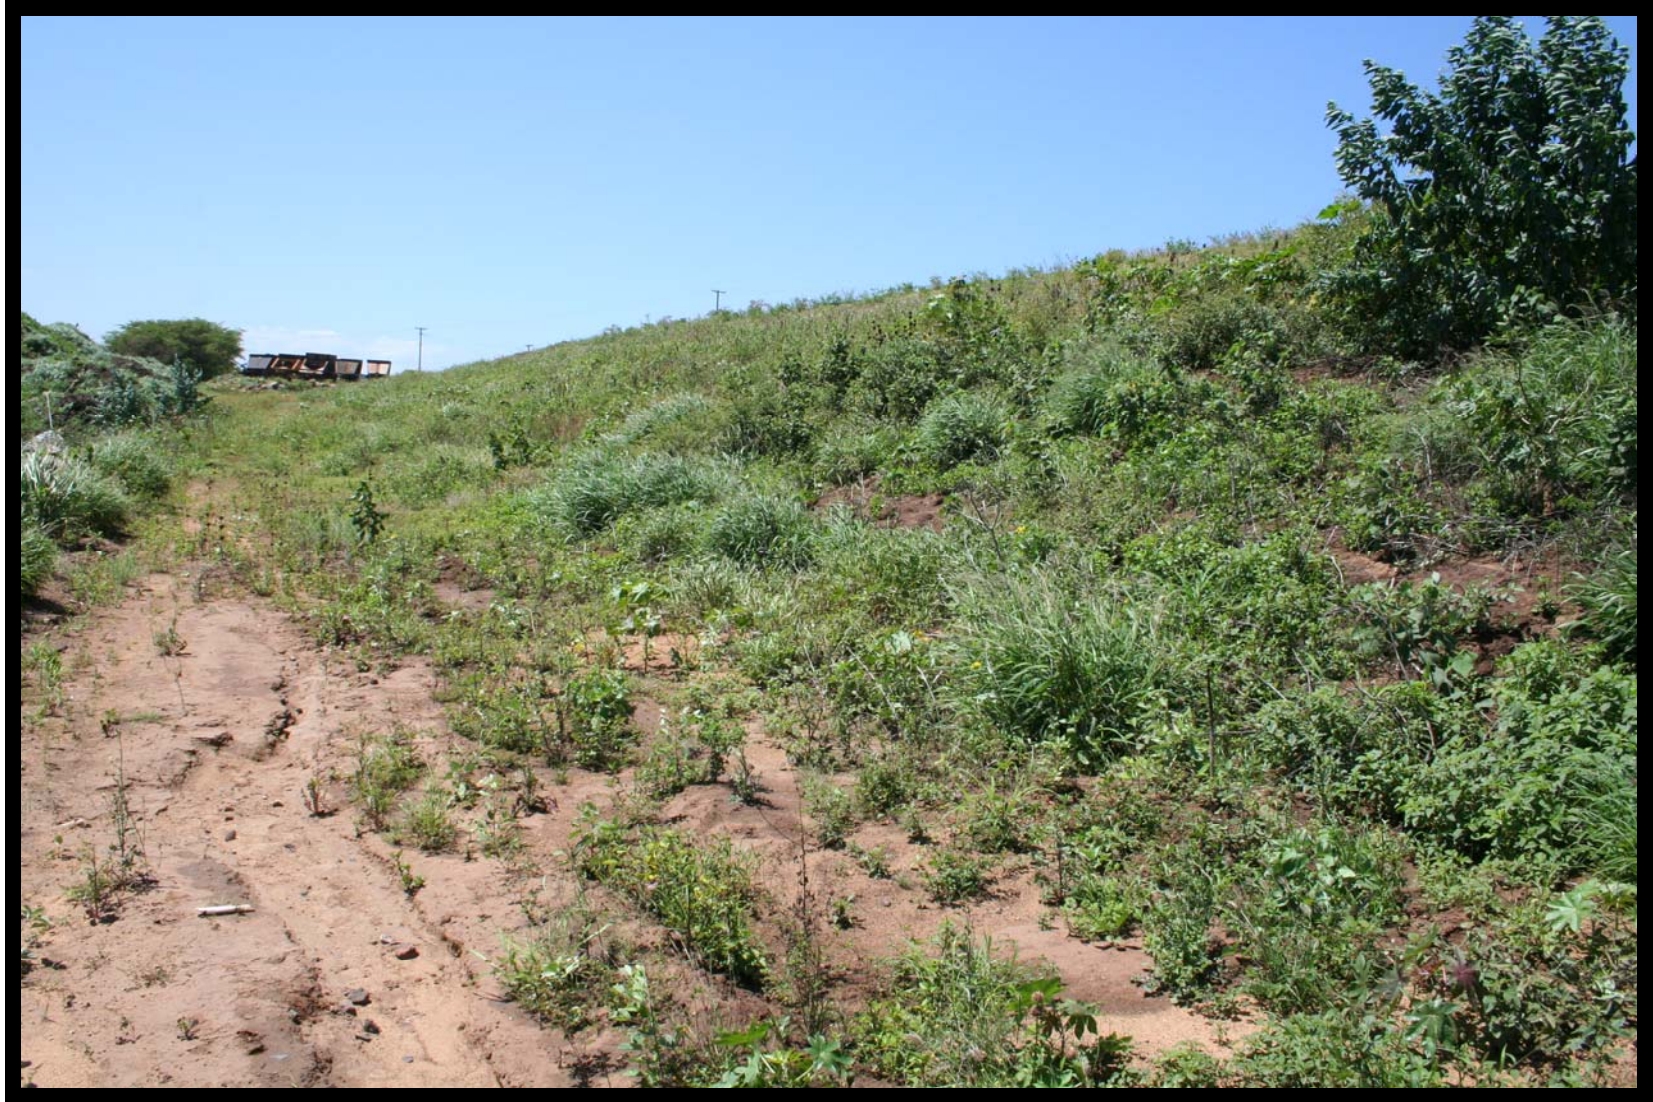
141 east toe - East embankment toe with no access and sparse grass

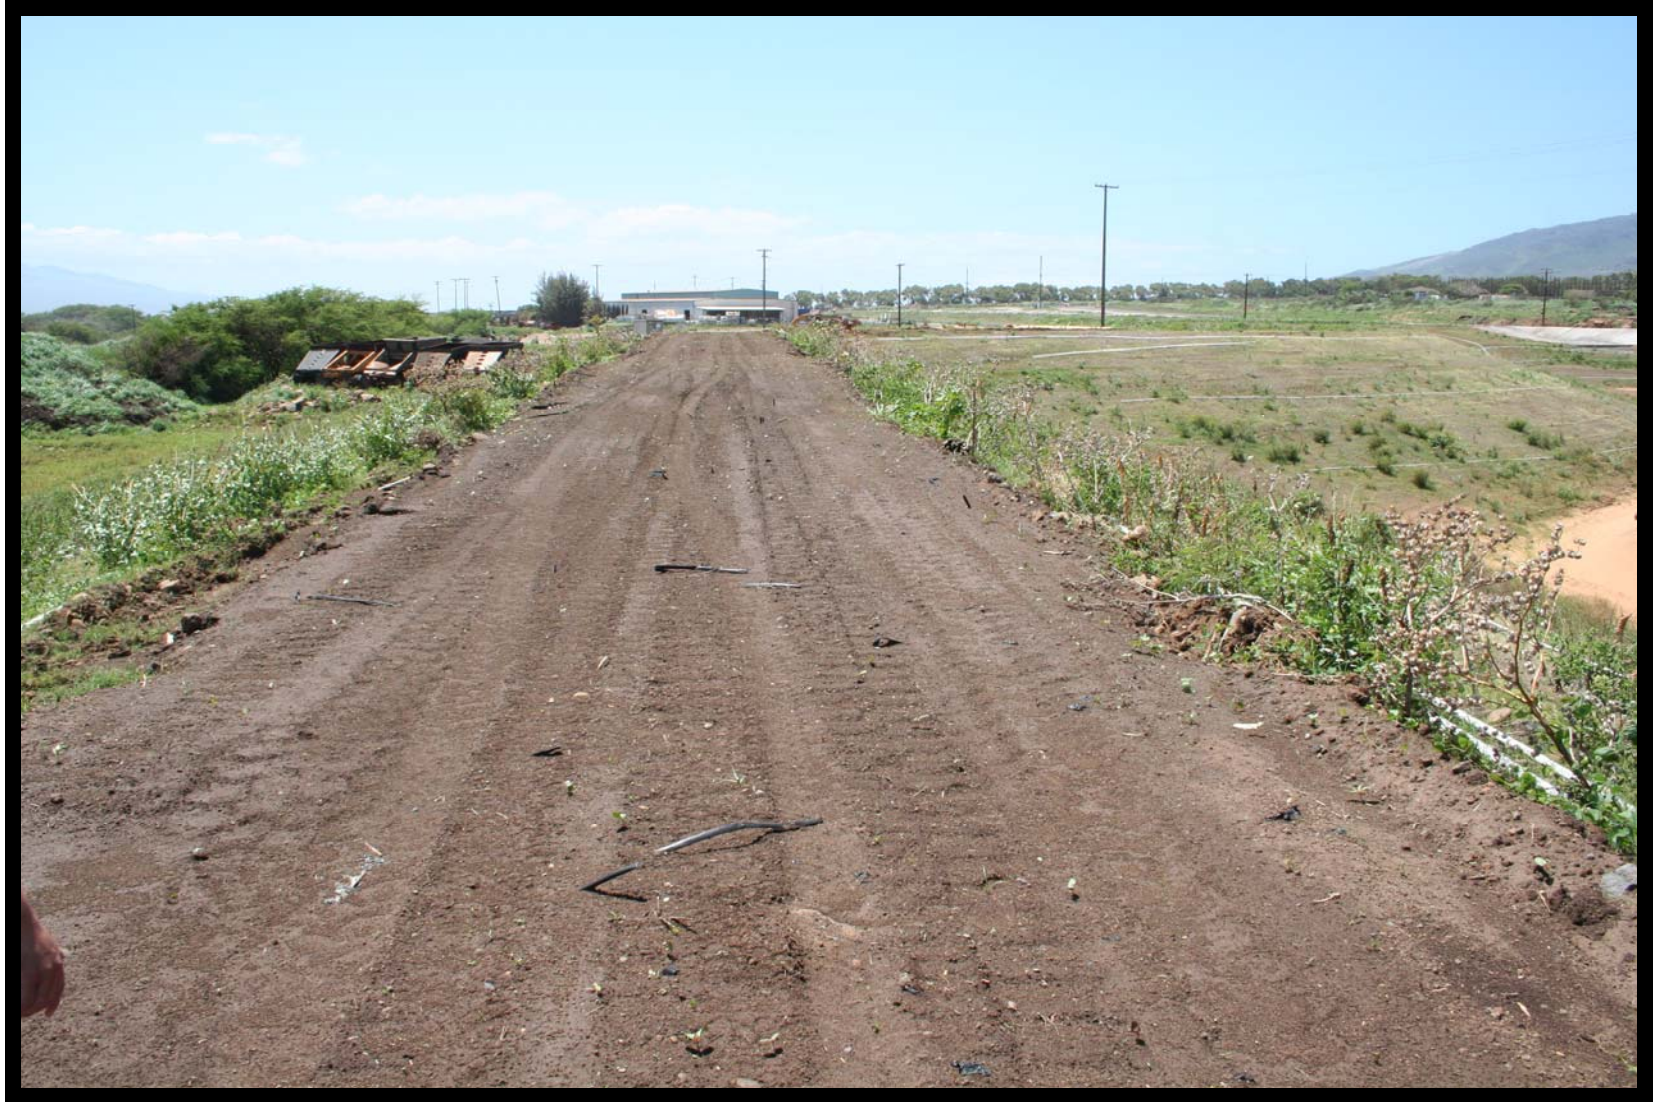
141 east side uneven crest - Crest area that is about 1' lower than other areas

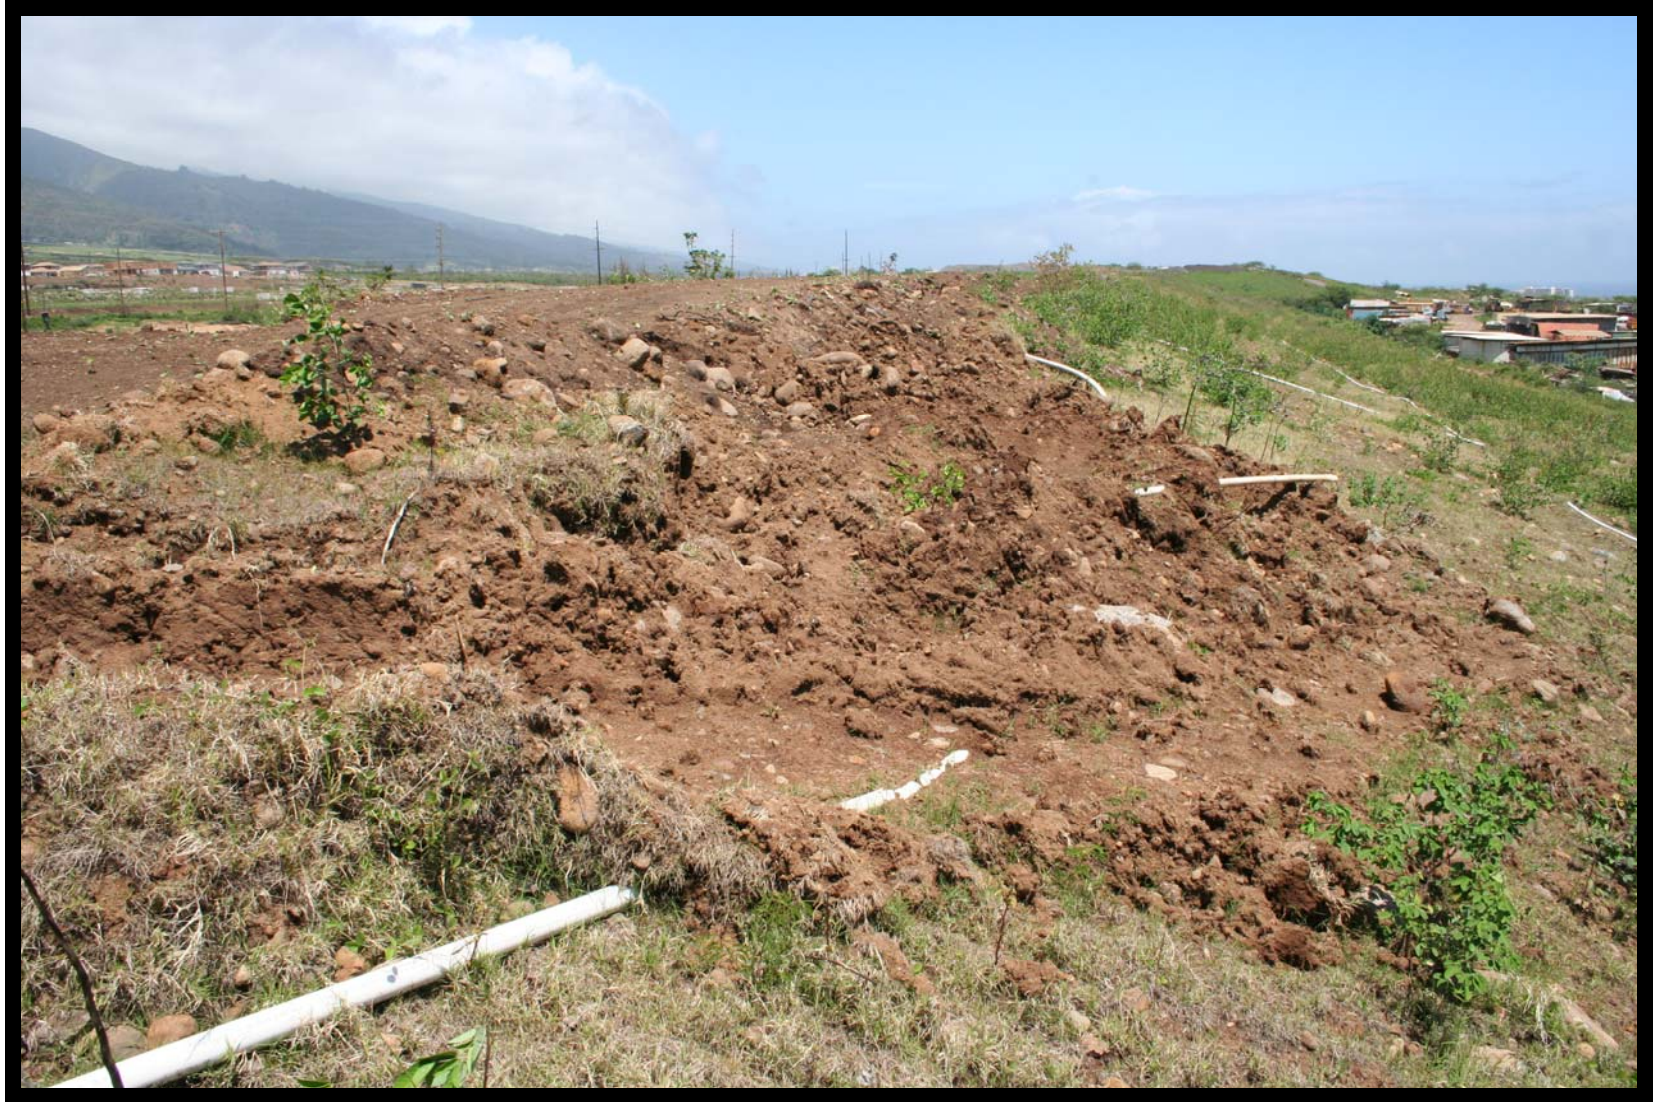
141 east side ruts - Ruts on crest near southeast corner
